Influence of Insertion Torques on the Surface Integrity in Different Dental Implants: An Ex Vivo Descriptive Study

Abstract: Background: The primary objective of this ex vivo study was to assess the influence of increasing insertion torques on three types of dental implants and possible alterations of their microgeometry after the application of three different torque intensities. Methods: 27 implants of 3 different implant brands (Groups A, B and C) were placed in cow ribs using 30 Ncm, 45 Ncm and 55 Ncm insertion torques. The implants were subsequently removed using trephine burs, and SEM analysis was carried out in order to detect implant surface and connection changes, as compared to the implant controls. Results: Surface deformations were predominantly observed on the third apical part of the implants. The alterations presented with increasing insertion torques, with 45 Ncm being the threshold value. Prosthetic connections were also compromised. Conclusions: The changes sustained by the implants were proportional to the insertion torque they were subjected to; 45 Ncm and greater insertion torques resulted in more consistent damage, both on the implant surface and the implant

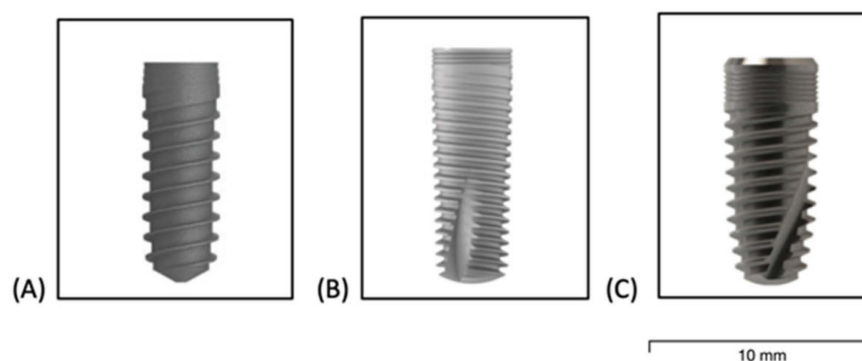
Figure 1. Implant models of the 3 brands: Group (A): 4.0×10 mm; Group (B): 3.75×10 mm; Group (C): 4.20×10 mm.

Group A implant used in this study was a grade 5 Alloy Al6V4, self-tapping conical implant with internal connection and platform switching. The type of surface was a thermochemical treatment consisting of an alkaline immersion followed by a heat treatment (Figure 1A).

Group B is a conical implant with a conical connection with a surface comprised of grade 23 titanium alloy Ti-6Al-4V-ELI (extra-low interstitial). The surface treatment of this group was a combination of sandblasting and acid etching (Figure 1B).

Group C is a grade 4 titanium (cold forming method) conical implant with an internal hexagonal connection. It presents a surface treatment consisting of sandblasting and double acid etching, creating a surface with a roughness of 1.4 μm (Figure 1C).

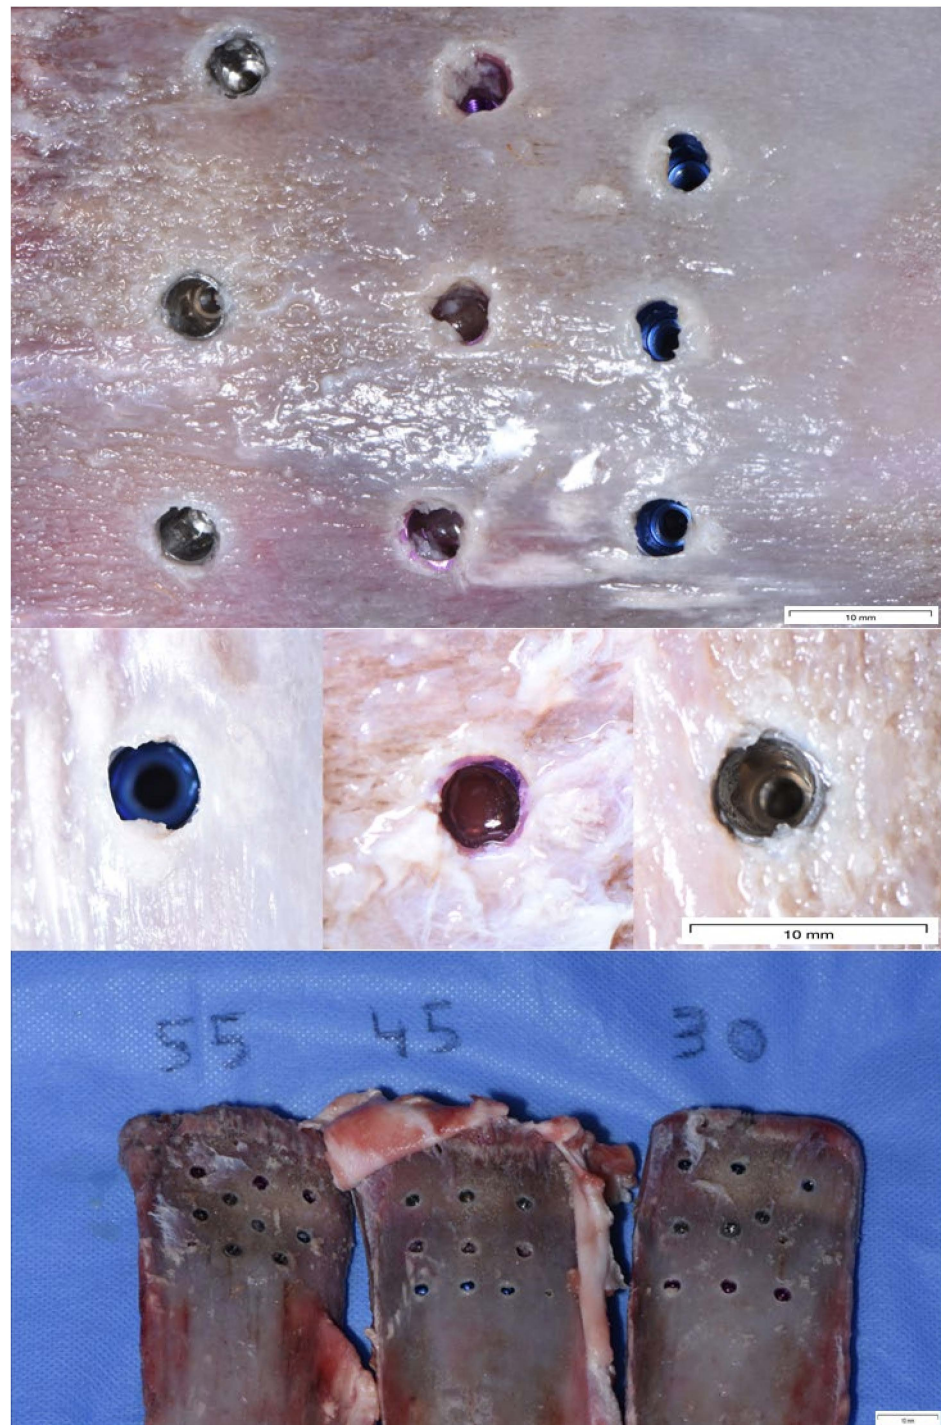
Figure 2. Picture of the 27 implants placed in 3 porcine ribs in which 3 implants for each brand were placed with the same insertion torque. The first rib on the left of the image was inserted with 9 implants of the 3 brands at 55 Ncm torque, the middle rib with 9 implants of the 3 brands at 45 Ncm, and the right rib with 9 implants of the 3 brands at 30 Ncm.

A total of 3 porcine ribs (provided by MAXYLAR BONES, SL, Barcelona, Spain) were used for this experiment. The first rib was used to place 9 implants with 30 Ncm, the second rib to place 9 implants with 45 Ncm, and the third rib to place 9 implants with 55 Ncm (Figure 2). In total, 27 implants were placed with different insertion torques. The same experts were responsible for implant placement, following a strict protocol recommended by the implant system manufacturers.

Three implants of each brand were placed in the different ribs so that the bone quality of the ribs did not influence the results. All implants were placed with a motor. The three experts (SA, SG, AG) always placed the same implant brand. The ribs were of type 2 bone quality, according to Lekholm and Zarb. Once the implants were placed, they were removed from the rib, using a trephine bur, for their subsequent microscopic observation.

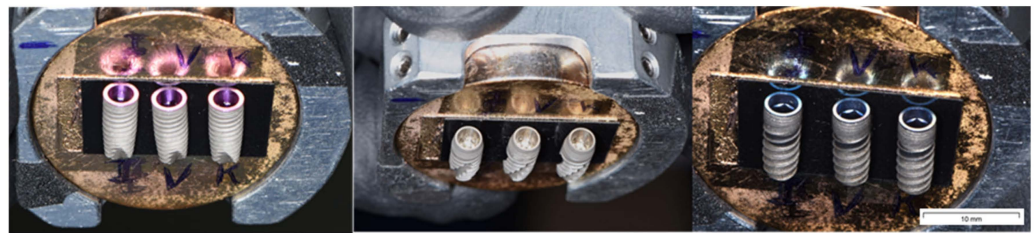
Figure 3. Implants placed in the sample holder of the SEM. Each implant brand was analyzed. The implants subjected to the highest torque presented visually detectable surface deformations at the level of the apical third.

The sample was fixed with two bolts on a sample holder parallel to the floor, and after a few seconds, a vacuum was created in the pre-chamber of the microscope. After this time, the preparation was placed inside the vacuum chamber for its subsequent analysis. The measurement system consisted of analyzing each implant of the same insertion torque of each brand in the same order (Figure 3).

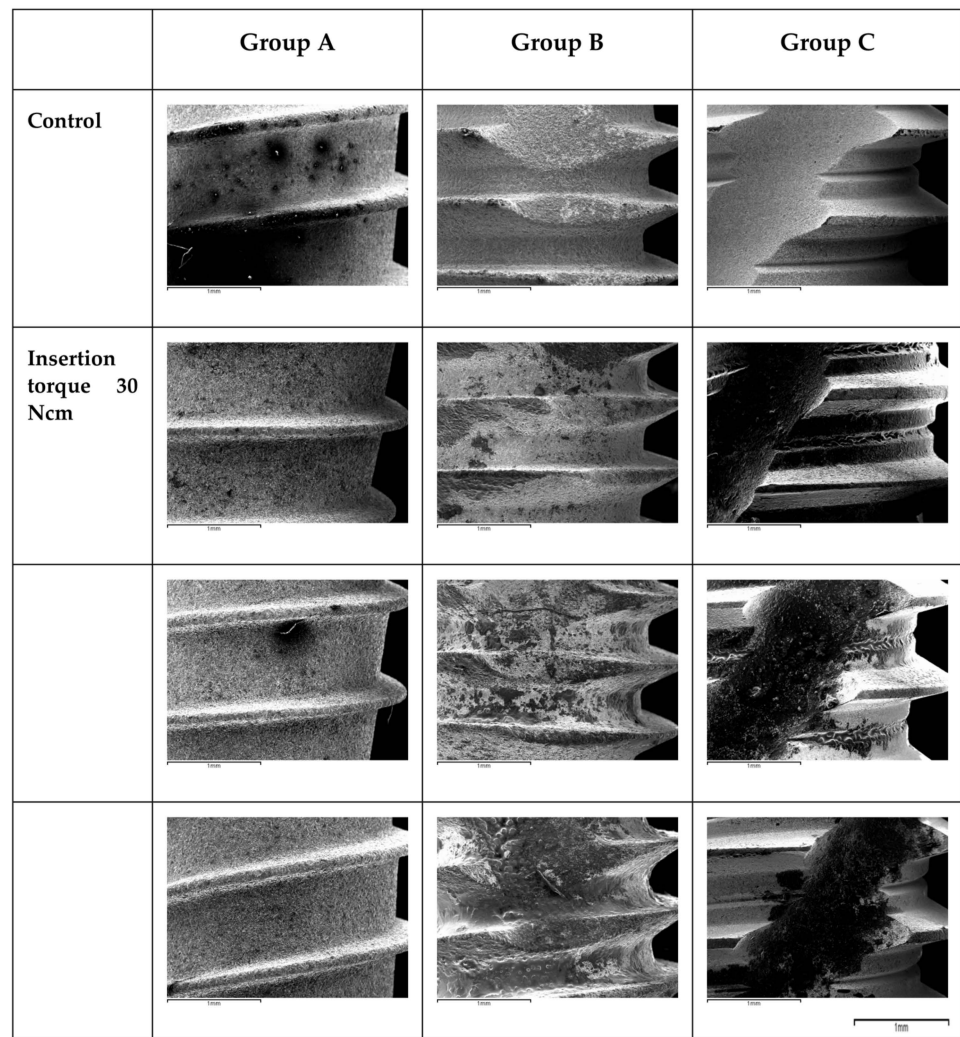
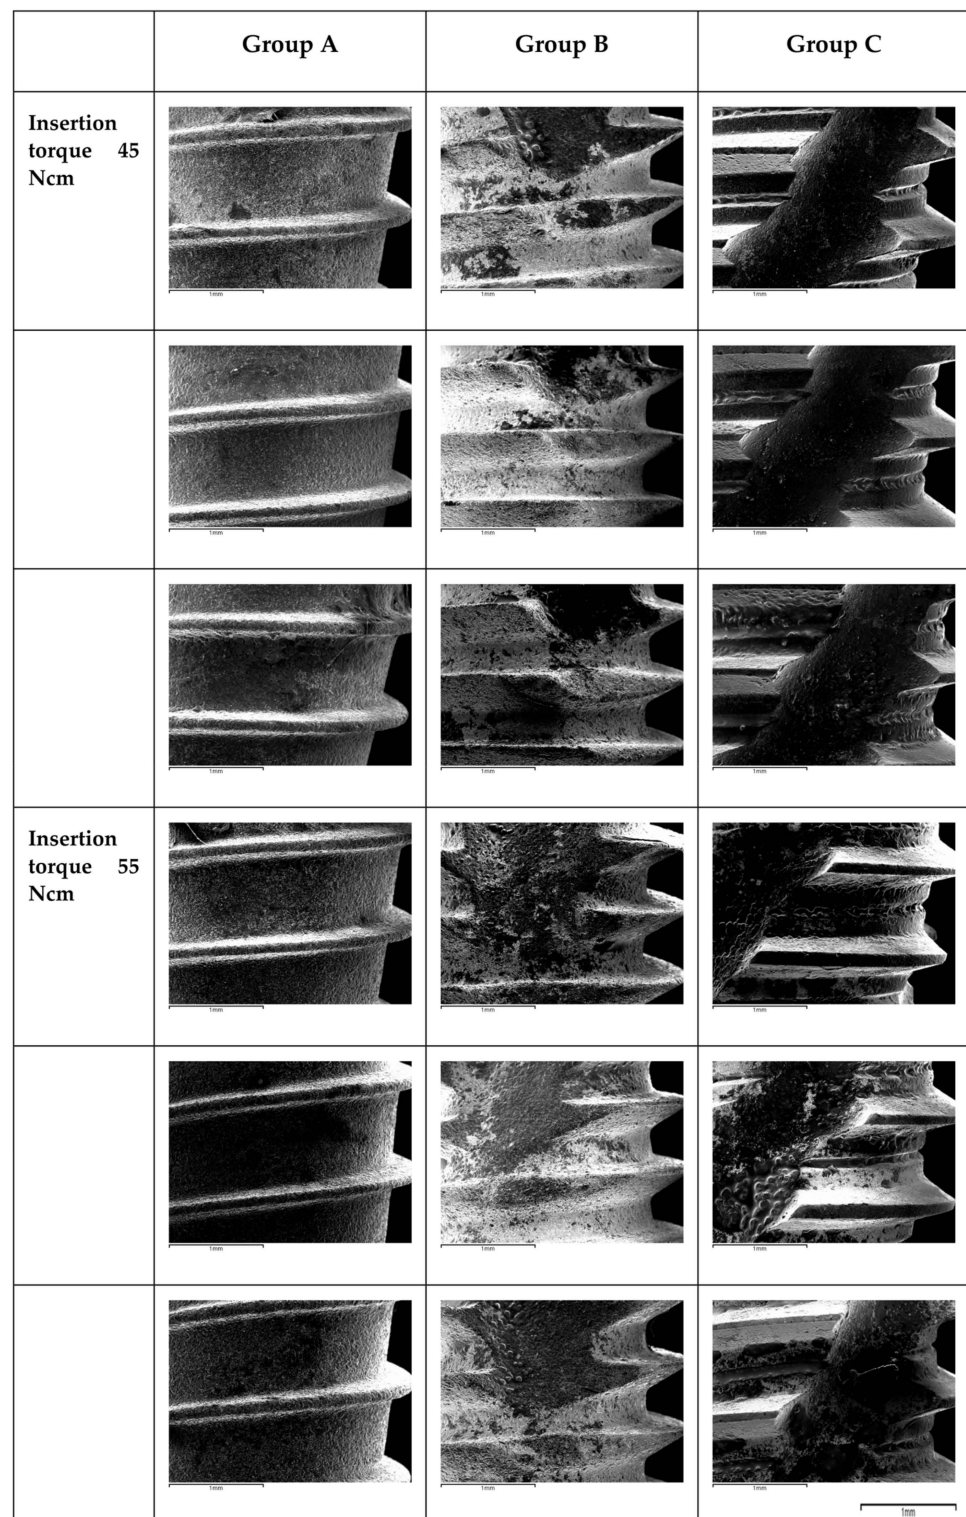
Figure 4. (a) SEM images (50 \times) of the apical third samples of each group are shown after the application of the predetermined insertion torque values. The images are of the 9 implants (Groups A, B and C) with their respective torques at 30, 45 and 55 Ncm. (b) SEM images (50 \times) of the third apical samples of each group are shown after the application of the predetermined insertion torque values. The images are of the 9 implants (Groups A, B and C) with their respective torques at 30, 45 and 55 Ncm.

The SEM analysis showed that after an application of 30 Ncm, only small marks were observed on Group A implant surface and connection, while Group B and Group C implants showed more surface alterations. Many of the minor surface features were less noticeable in the apical third, indicating that they may have been removed. The apical cutting threads were subjected to a large level of tension, and the damage was concentrated in this area for the three different brands.

Independently of the implant group, the alterations were localized at the more apical part, where threads were randomly broken during insertion. Furthermore, on the thread crests, topographical changes such as surface leveling and abrasion facets were seen (Figures 4a,b and 5a,b).

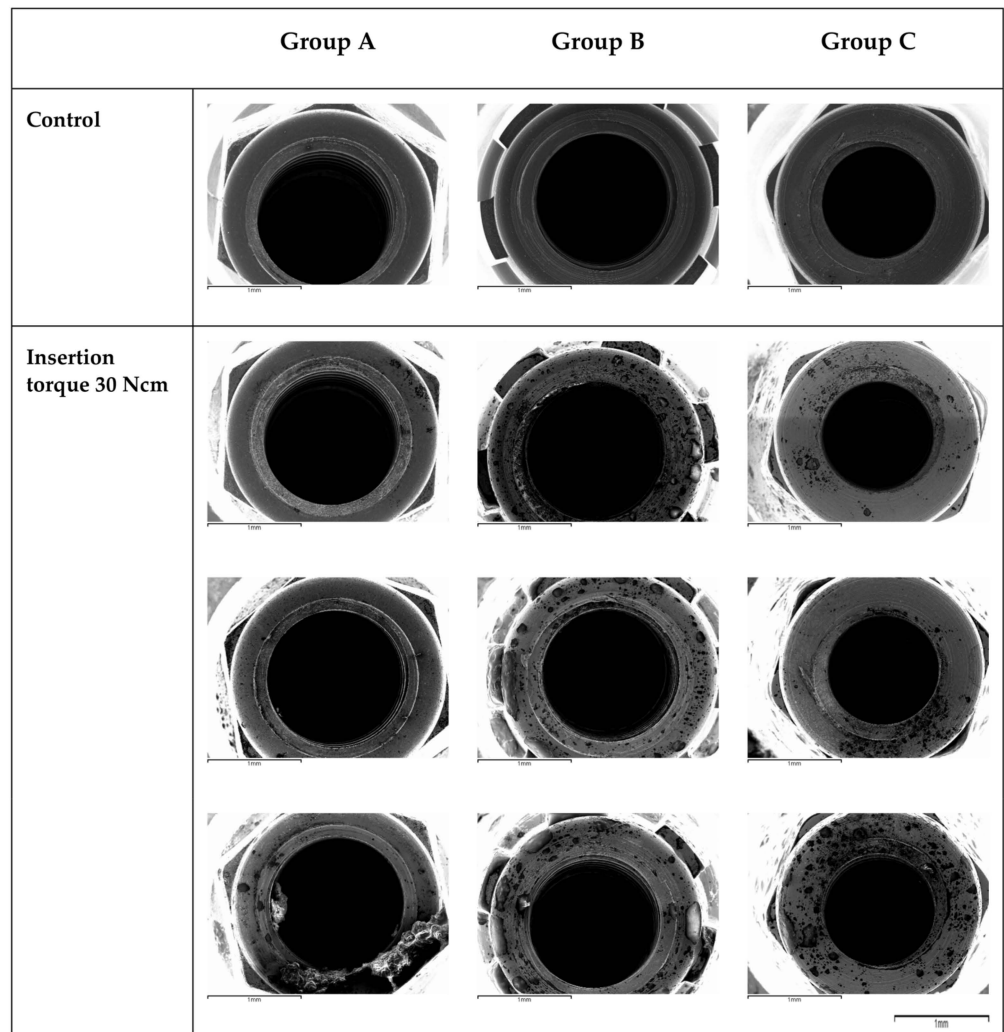
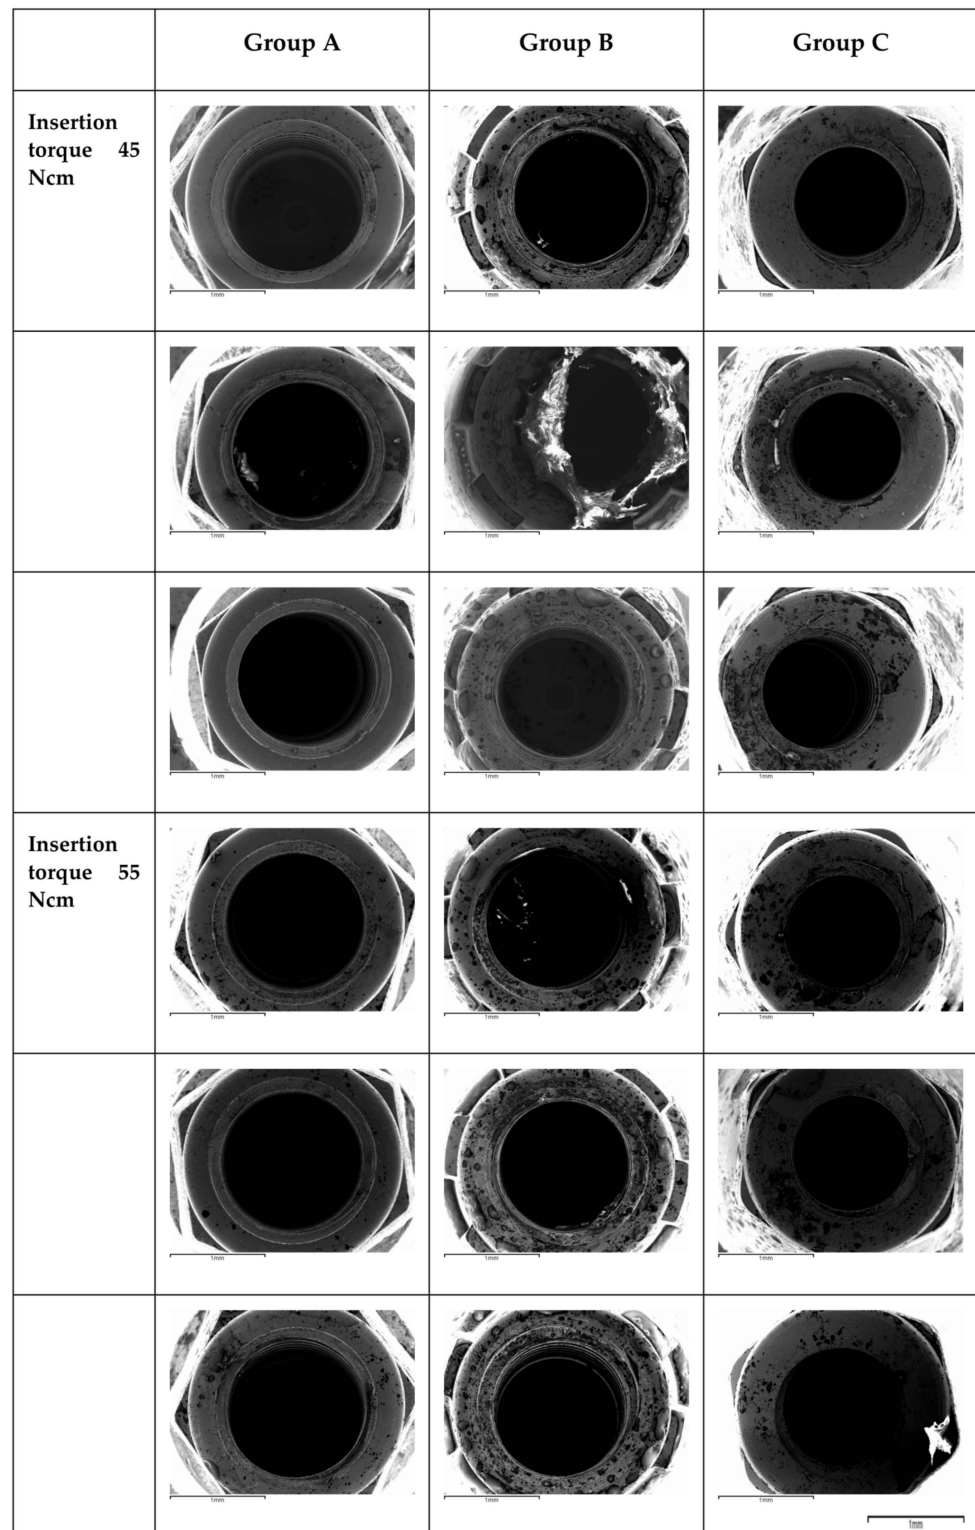
Figure 5. (a) SEM images (50 \times) of the connection samples of each group are shown after the application of the predetermined insertion torque values. The images are of the 9 implants (Groups A, B and C) with their respective torques at 30, 45 and 55 Ncm. (b) SEM images (50 \times) of the connection samples of each group are shown after the application of the predetermined insertion torque values. The images are of the 9 implants (Groups A, B and C) with their respective torques at 30, 45 and 55 Ncm.

The same scenario was shown at the level of the connection of the implants. It was observed that from the application of 45 Ncm and 55 Ncm, deformations were observed at the level of the implant connection. As we can see in the SEM images, the higher the torque of insertion was, the more substantial the alterations were.
